Published in:
Energy Procedia

12th International Renewable Energy Storage Conference, IRES 2018

Corrosion in Heating and Cooling Water Circuits - A Field Study

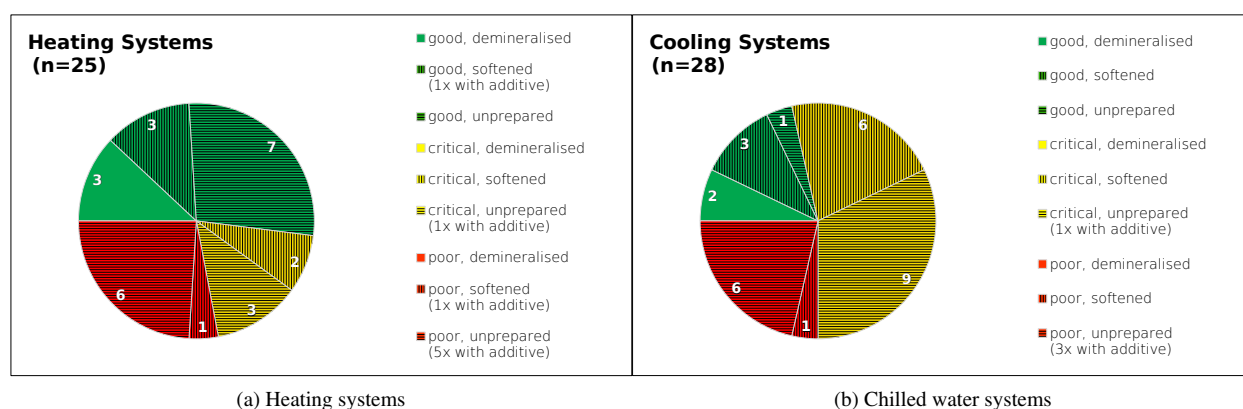
Fig. 1: Fill water and system condition 'good', 'critical' and 'poor' based on threshold values and project experience.

Non-optimum conditions and corrosion effects were found in several objects, some of which were relatively new or even not yet occupied. Of the 53 systems which were assessed on the basis of dissolved and particulate metals, on-site measurements and anions/organic carbon, 34 systems showed poor or critical conditions (Fig. 1).

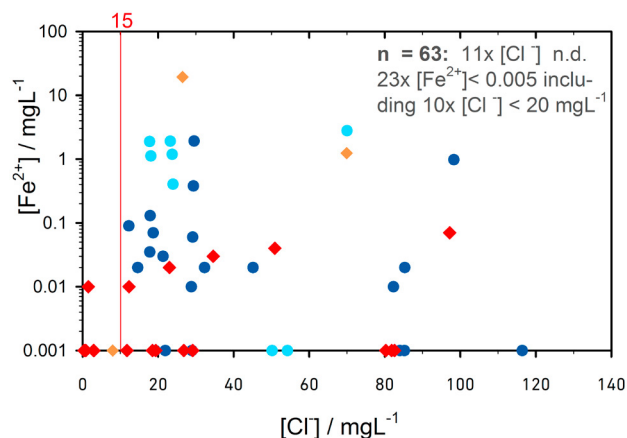
Fig. 2: Cl⁻ and Fe²⁺ concentrations. Dots: Cooling systems; squares: heating systems; Light colours: pH < 8.5; sound colours: pH ≥ 8.5. Note that [Fe²⁺] were 23 x < 0.005 mg L⁻¹ with 10 systems with [Cl⁻] < 20 mg L⁻¹.

Dissolved oxygen concentrations ranged from 10 to above 100 µg L⁻¹. Concentrations >50 µg L⁻¹ were found in n = 7 cases, >100 µg L⁻¹ in n = 4 cases. No parameter predicted the occurrence of corrosion alone. pH and conductivity were of highest significance when linearly correlated. Of the water constituents, chloride was the species of highest single importance, known to damage protective magnetite layers [7, 12]. Installations with chloride concentrations below 15 mg L⁻¹ in the system water showed no signs of enhanced corrosion, whereas concentrations above 15 mg L⁻¹ often showed increased corrosion. Corresponding conductivity measurements showed good system performance up to 250 µS cm⁻¹. However, some were in good conditions nonetheless (Fig. 2). The findings are consistent with the notion in corrosion science that the corrosion behaviour of metals is “governed by complex interactions involving many parameters manifesting itself in numerous often unanticipated forms” [7]. The worst conditions were found in systems treated with chemicals meant to prevent corrosion.

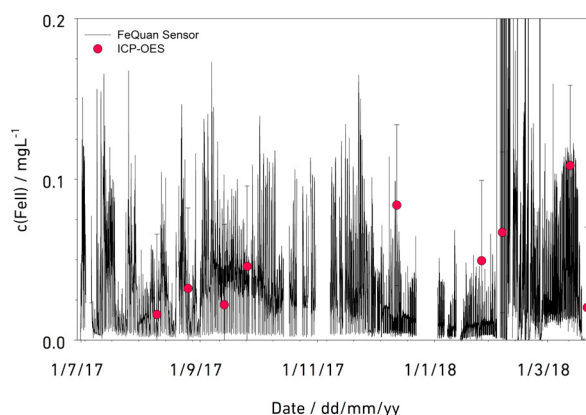
Fig. 3: Continuous ferrous iron-measurement (sensor) in a building heating cycle and laboratory point measurements (red dots).

Application of the sensor method revealed hidden action in several buildings (undocumented feed-ins, oxygen ingress, loss of system pressure). The sensor signal generally reflects dissolved iron concentrations (Fig. 3, example from a heating circuit). In some cases, the sensor response differed from the laboratory values: Fig. 4 shows monitoring data from a chilled water system of a university building with softened fill water shortly after commissioning. On-site parameters and calculated ferrous iron activity normalised to concentration levels are shown in comparison with soluble iron concentrations. Sudden changes in the on-site parameters starting in the beginning of August lead to an increase in iron concentration reflected by both the laboratory and sensor measurement. In the middle of September, another sudden change detected by pH and redox potential simultaneously with a change in tendency of the conductivity curve was recorded. After the spontaneous decrease in system water quality, acetic and propionic acids were found in the system water (Table 2). Acid producing bacteria, most likely the cause of the change in pH and iron content starting in August, were found abundant shortly after the described incident (Table 3). They may feed on dissolved organic matter, possibly introduced via softened water from a cation exchange resin. A possible explanation for the changed conditions is the feeding-in of make-up water, which could be supported by the increase in system pressure and the redox potential. The second sudden change in September was probably due to connection or disconnection of a system segment. The sensor shows an early “all clear” before the laboratory values also stabilise at a low level. For the disparities between the sensor and the laboratory values, there may be two explanations: The first is that the

sensor responses are low because Fe(II) is present in complexes with low Fe(II) activity. The second is the presence of compounds which can solubilise Fe(III) from Fe(III) oxides, thus passing the syringe filter, such as electron shuttles or Fe(III)-chelators released by iron reducing bacteria [11] like *Halomonas spp.*

(see Table 3; their capacity to reduce Fe(III) up to elemental iron is described in [6]). Given the later decrease in the laboratory values and the occurrence of *Halomonas*, the latter is more likely. For detection and tracking of corrosion related processes in technical building services, the applied sensor and visualisation turned out to be sensitive tools. Monitoring solves problems arising from lack of information, enabling effective quality management of hydraulic systems.

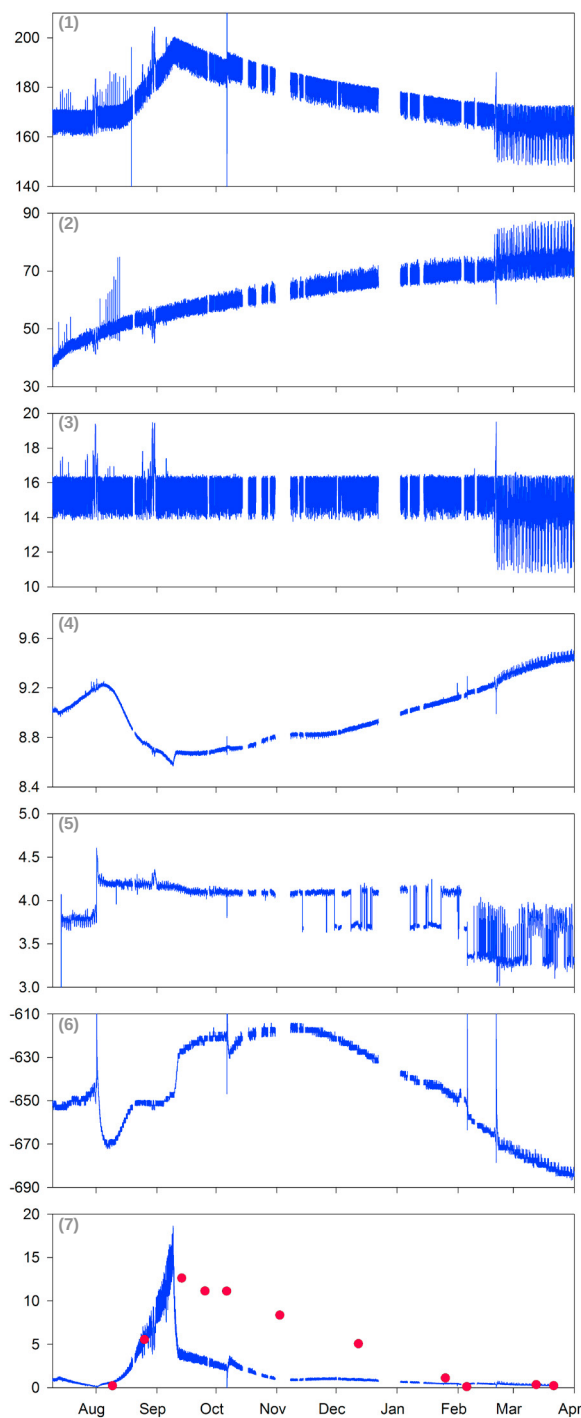
Fig. 4: Data from chilled water circuit. 1-6: Specific electric conductivity [$\mu\text{S cm}^{-1}$], oxygen [$\mu\text{g L}^{-1}$], temperature [$^{\circ}\text{C}$], pH, pressure [bar], redox potential [mV]. 7: Fe^{2+} activity normalized to concentration [mg L^{-1}] from sensor (line) and Fe_{aq} concentration determined by ICP-OES.

Table 2: Organic acids and organic carbon [mg L^{-1}] in water samples from a chilled water circuit, see Fig. 4 for monitoring data.

Table 3: Dominant bacteria in a water sample from a chilled water circuit (see Fig. 4 for monitoring data) taken on 13/09/17. The analysis was carried out by 16S rRNA sequencing. Values are the percentage of sequences related closest to the genus stated.

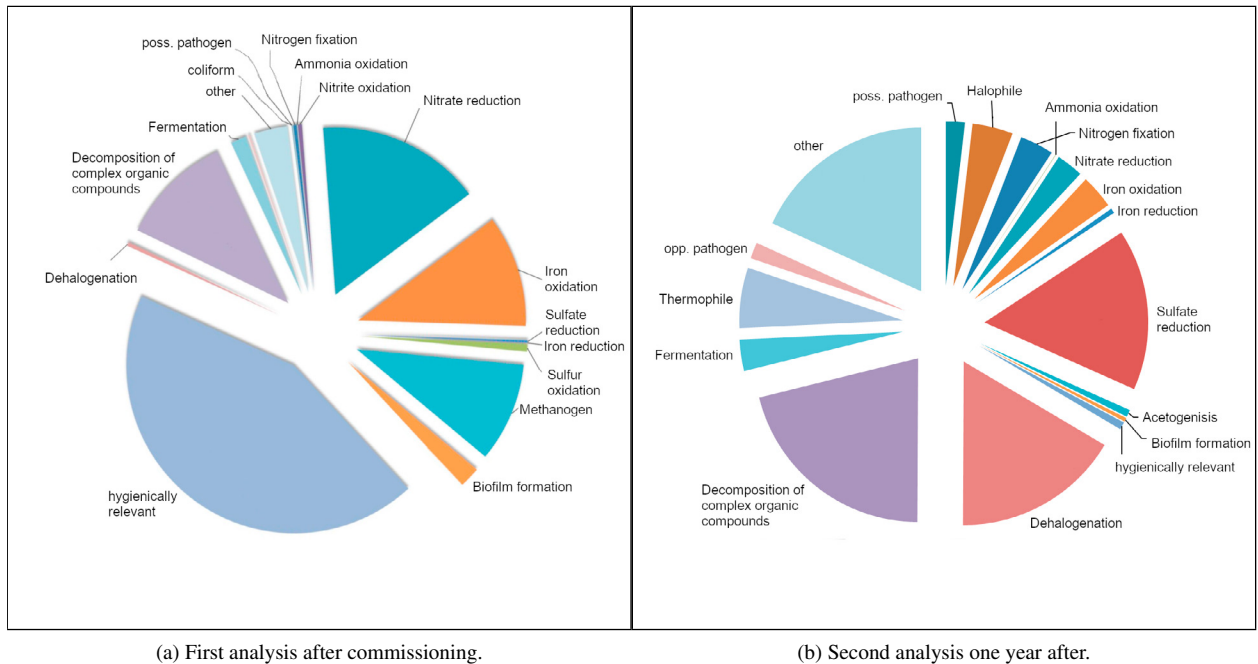
Fig. 5: Assessment of the known metabolic capacities of the microbial community in samples from a chilled water system. Some determined bacteria may be included in more than one capacity group. Sequences may originate from living or dead cells.

The overall process is largely independent from oxygen concentration and pH. Sulfur and sulfide are not consumed. Fig. 5 shows the bacterial community of another chilled water circuit after initial filling of the system and one year later. The composition of the bacterial community has vastly changed by the time

the second sample was taken. A succession from nitrate reducing, iron oxidising bacteria to sulfate reducing bacteria was observed. Sulfate concentrations decreased from 46 to 0.6 mg L⁻¹. Nitrate was absent in both samples.
